# Study of the “Palacio Foral” building structure in Bizkaia

Bizkaia, Bilbao, Spain / 2001

masonrywork  
Diputación Foral de Bizkaia  
Diputación Foral de Bizkaia  
diagnosis and intervention start up

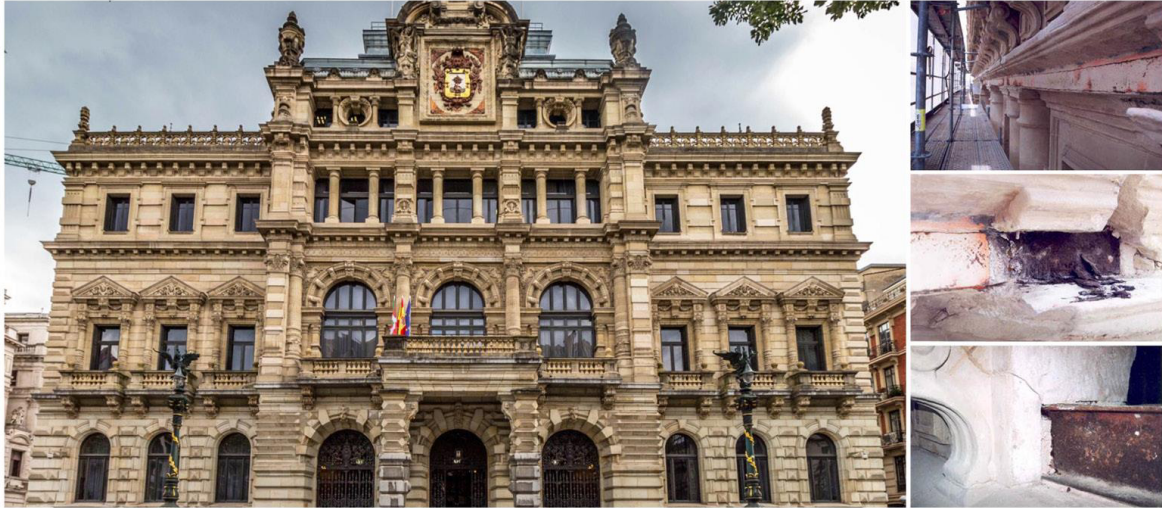
At the beginning of spring 2000 while working on the rehabilitation of the elegant Regional Palace owned by the Bizkaia Regional Deputation, CONSTRUCCIONES AMENABAR encountered broken lintels, deformed cornices and deteriorated, out of plumb, pinnacles on the last floor of the building.

After examining the structure carefully and in great detail, it was concluded that the corrosion generated by steel profiles acting as lintel-joists, had produced the expansion that finally led to the fracture of the stone elements, aforementioned.

The rather daring solution consisted in removing these steel profiles and taking advantage of the possibilities of resistance of the stone lintels and the concrete elements (with rustproof reinforcement) which were set into the gaps left by the profiles.

All operations included wooden scaffolding made by CONSTRUCCIONES AMENABAR and were performed under strict control and constant supervision by FHECOR Consulting Engineers.
