Repair Project for the Isle of Arosa Bridge

Pontevedra, Spain / 2007

2000m long, joint-free, pre-stressed box girder
Xunta de Galicia

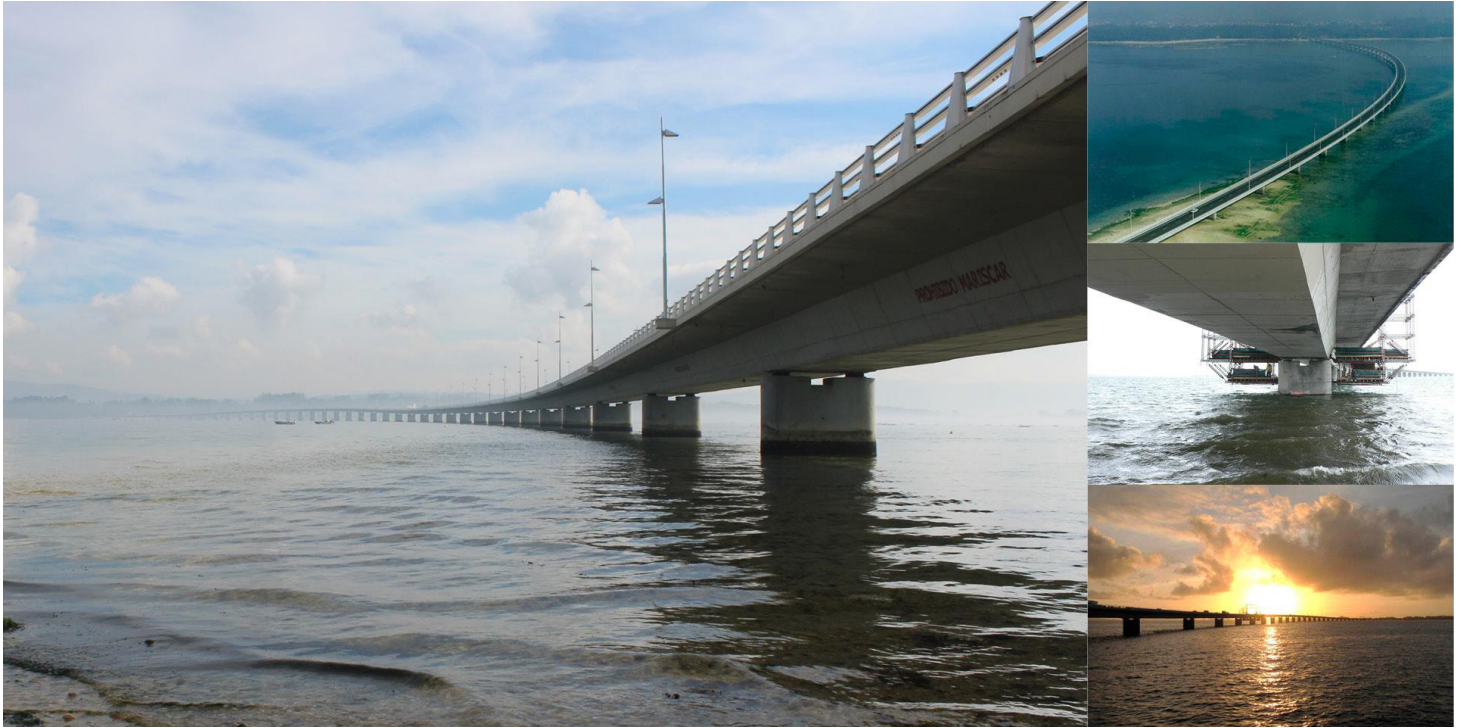
The repairs projected for the bridge shall assure that it will 'start from scratch' in terms of durability and in load bearing capacity, that is to say, around 50 years, as if it were just built. This statement has to be understood within the context of a system of inspection and maintenance which shall allow the behavior of the structure to be observed.

- Injection of the fissures in the box girder, and sanitization or the corroded metalwork on the lower part of the box, pier area, abutments and walkways adjacent to the bridge on the landside area. Fulfillment of repair works in said areas prior to the introduction of sacrifice anodes which impede surrounding areas becoming future anodes, susceptible to corrosion associated with the projected repair areas.

- Repair of gravel beds in the pier areas.
- Placement of sacrifice anodes in the tidal area and submerged areas, with the placement of a zinc mesh upon the shaft and a mortar cast in the space left between the face and a fiberglass mould bolted to the face.

- Painting of all external faces of the deck, abutments and piers (except those areas above high-tide level which are covered with the fiberglass moulds) with a waterproof, chloride-based paint, but which allows the drainage of internal water vapors. This strategy increases the resistance of the concrete and hence decreases the intensity or speed of corrosion and consequently the useful life of the structure.

- Painting of the inside of the box.
- Cleaning of support plates and protection with paint and repair of the neoprene bases in case of deterioration.
