# River Oria Bridge repair project

Itsasondo-Arama, Guipúzcoa, Spain / 2004

Owner  
Constructor  
Scope

diputación foral de guipúzcoa  
construcciones amenabar  
construction support

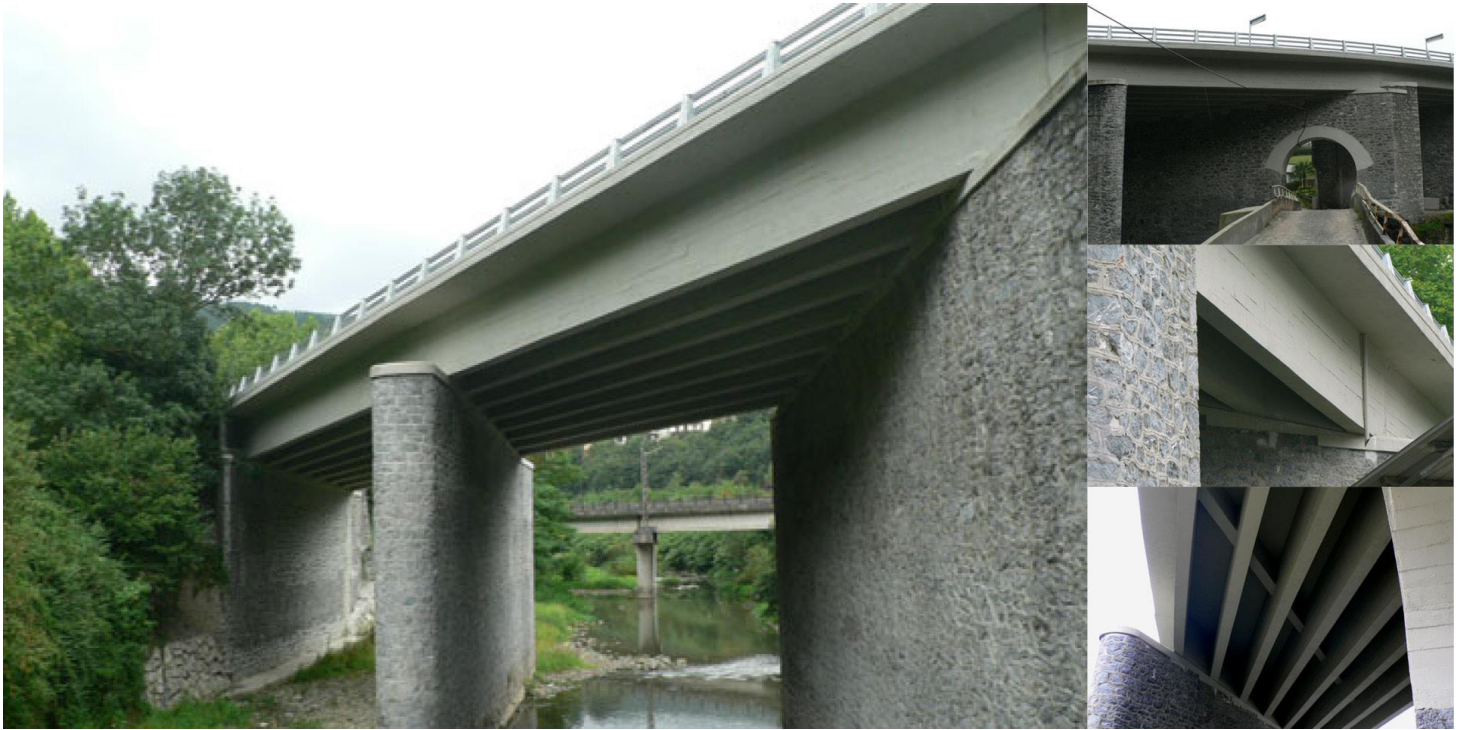
In June 2004, the repair works to the Itsasondo-Arama Bridge began, which are allocated the N°32 according to the code pertaining to the Regional Government of Guipúzcoa. The project forecast, albeit with little previous information, gave way to solutions, which once Works began, admitted pertinent changes and modifications, which would offer better and more economical results from a maintenance point of view.

Once the necessary calculations had been fulfilled, it was decided to undertake a structural refit which would permit continuity to the wearing course and eliminate joints, which are a constant source of problems on the road surface and for the durability of the concrete structure.

A new upper slab was projected and subsequently laid and although it increased the imposed load it offered a greater depth resistance and also permitted the placement of a vehicle safety barrier
